POST EARTHQUAKE INVESTIGATION FIELD MANUAL FOR THE STATE OF KENTUCKY

UNIVERSITY OF KENTUCKY
College of Engineering

Research Report
KTC-06-30/SPR234-01-1F

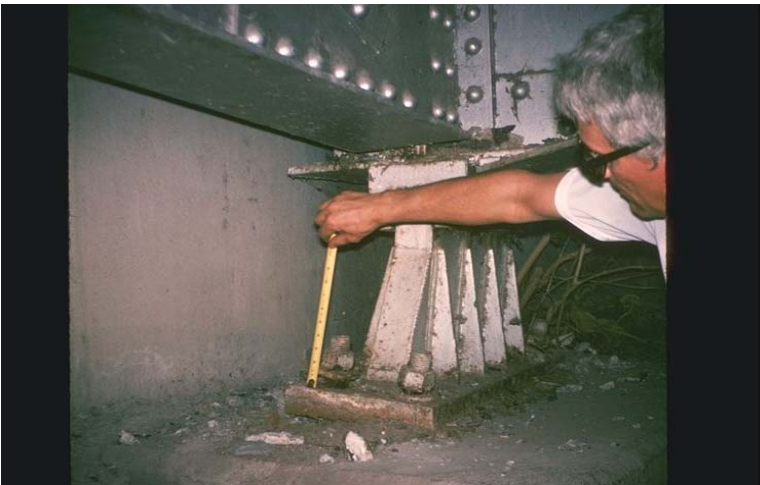
Figure 55 **Moderate Damage.** Crushed bearing assembly. Also note the slightly elongated bolts. (1)

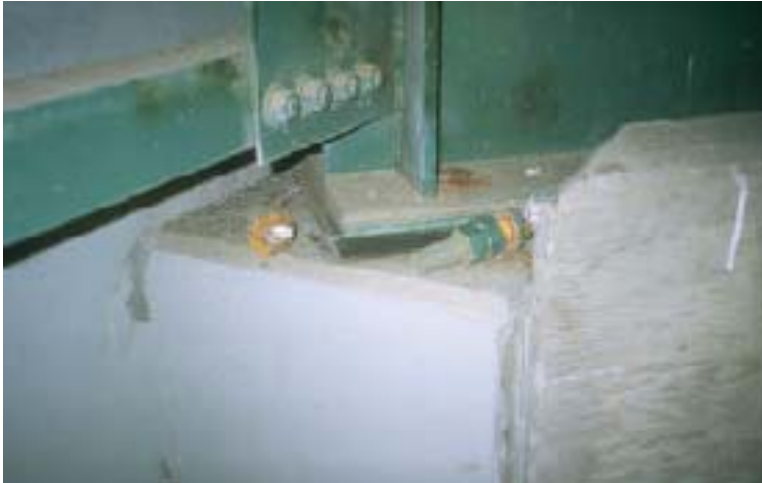
Figure 56 **Moderate Damage.** Sheared anchor bolts. (1)

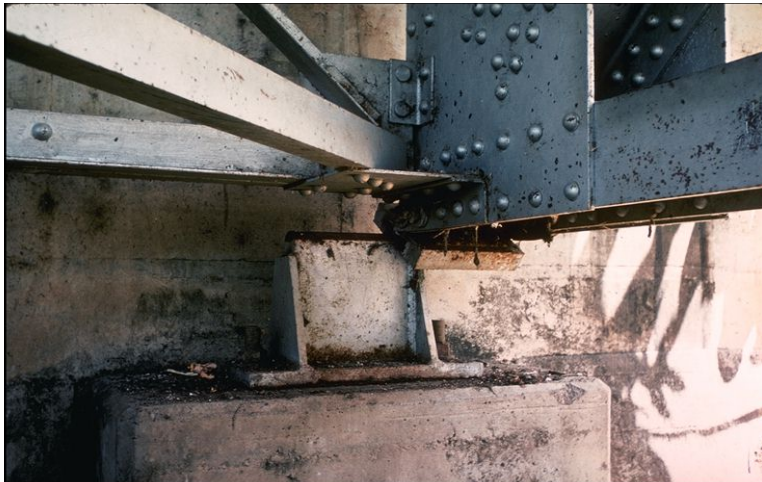
Figure 57 **Severe Damage.** Displacement of the steel girder off the bearing support. (1)

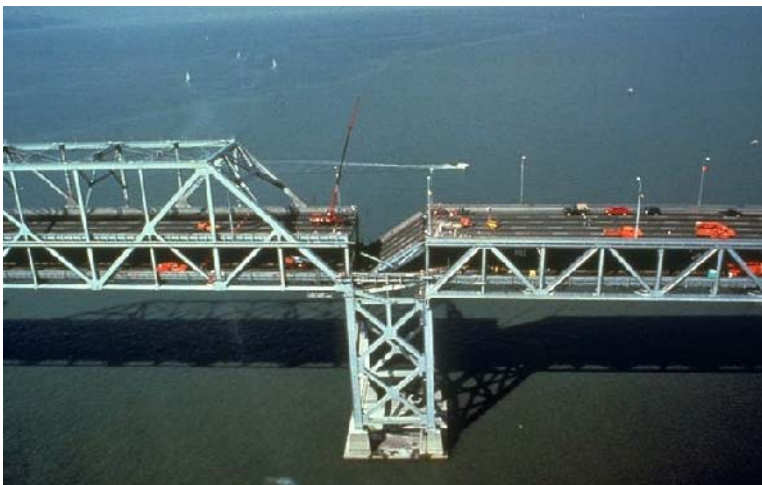
Figure 58 **Total Failure.** Unseating at the expansion joint. (1)

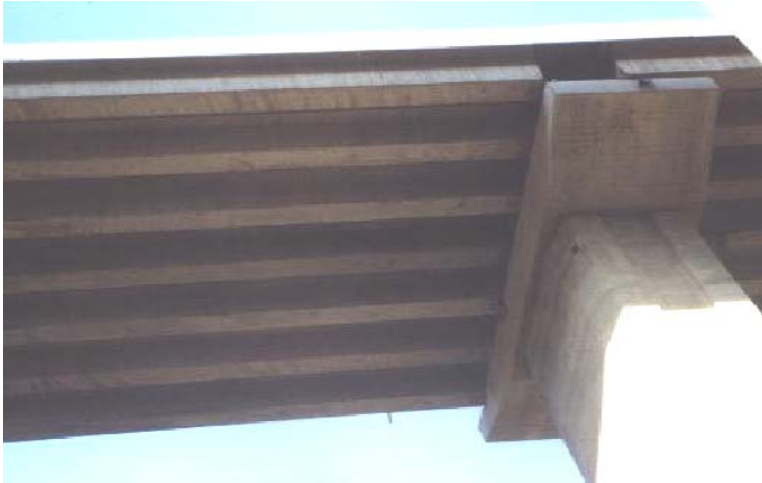
Figure 59 **Total Failure.** Unseating of the superstructure at the pier. (3)

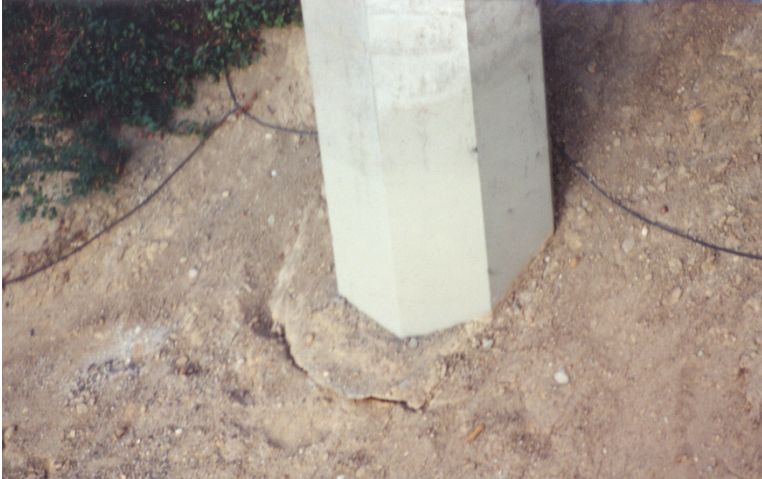
Figure 60 **No Damage.** Column movement evident by the ground cracking and displacement. (5)

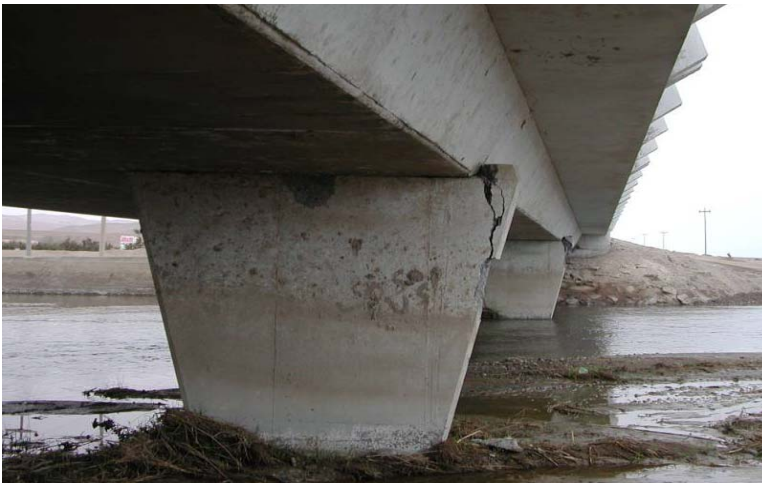
Figure 61 **Minor Damage.** Shear key element damage. (10)

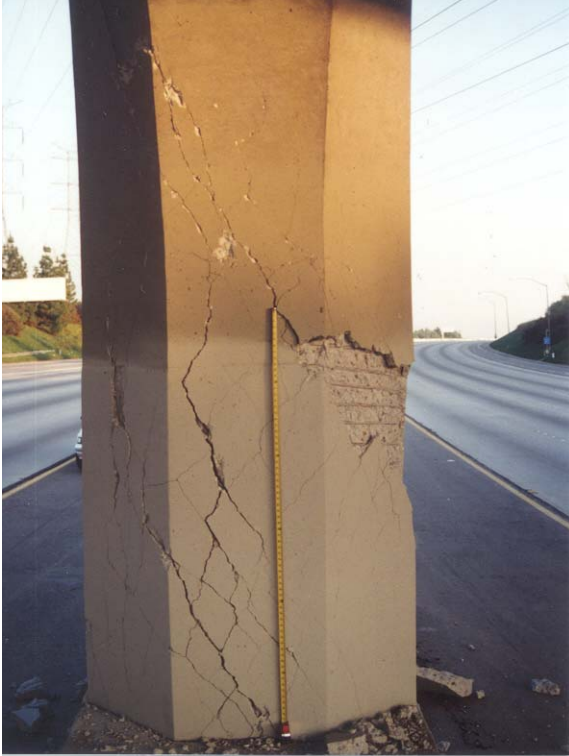
Figure 62 **Minor Damage.** Shear cracking of the concrete cover at the column base. (5)

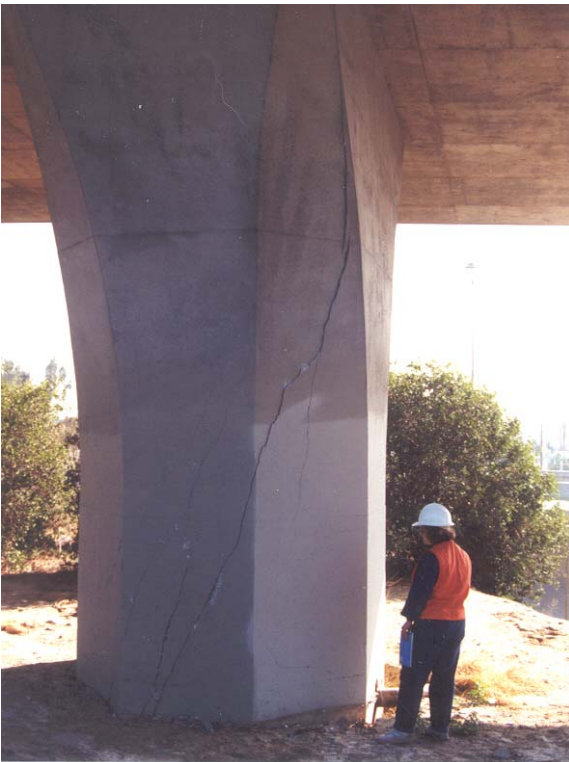
Figure 63 **Minor Damage.** Torsional/shear cracking throughout the column length. (5)

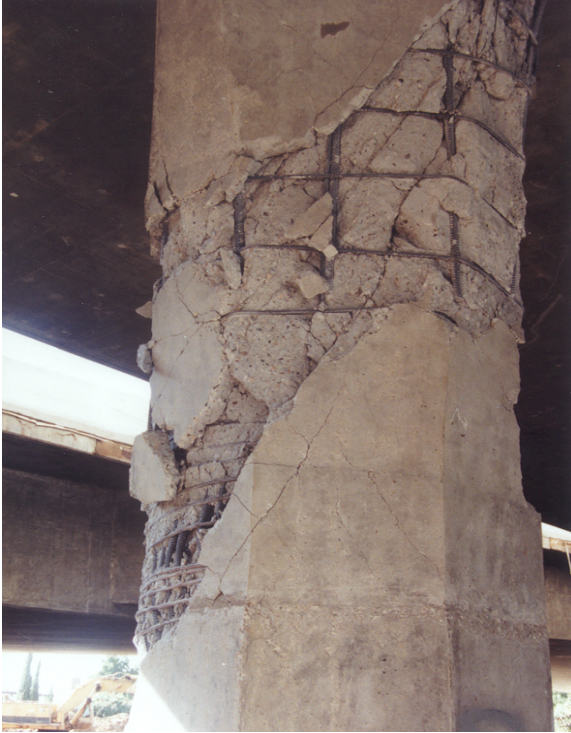
Figure 64 **Moderate Damage.** Shear failure of the column. The cracks have propagated into the core concrete and the vertical bars are beginning to buckle. (5)

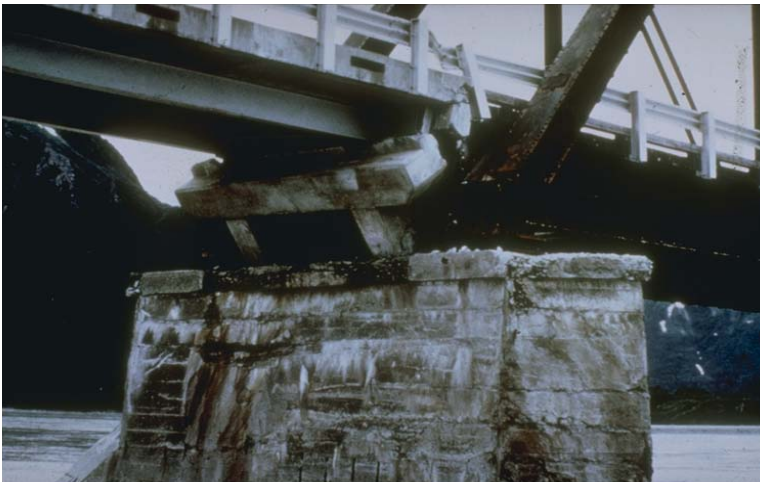
Figure 65 **Severe Damage.** Girder span was moved to the right, its concrete pedestal was rotated, and the girder span almost fell into the river. Note the shortening indicated by the buckling of the guardrail. (14)

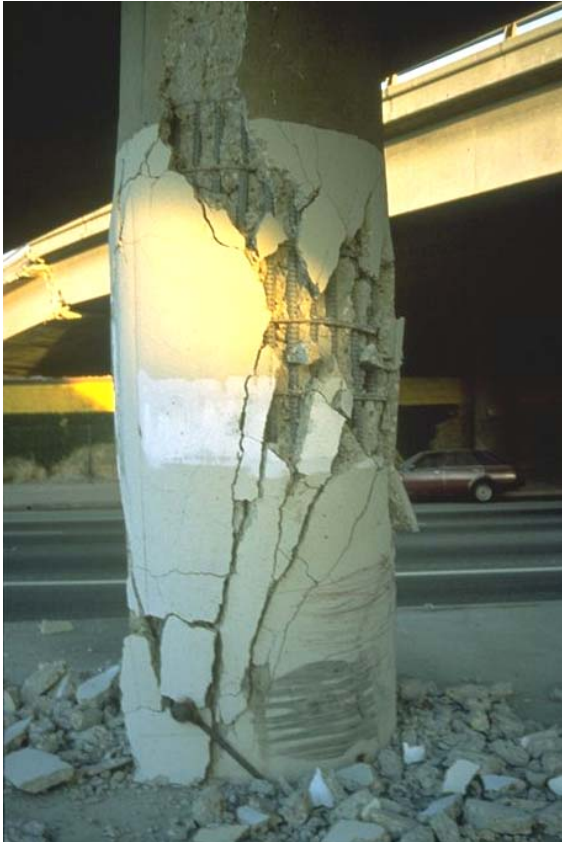
Figure 66 **Severe Damage.** Shear failure in column. (1)

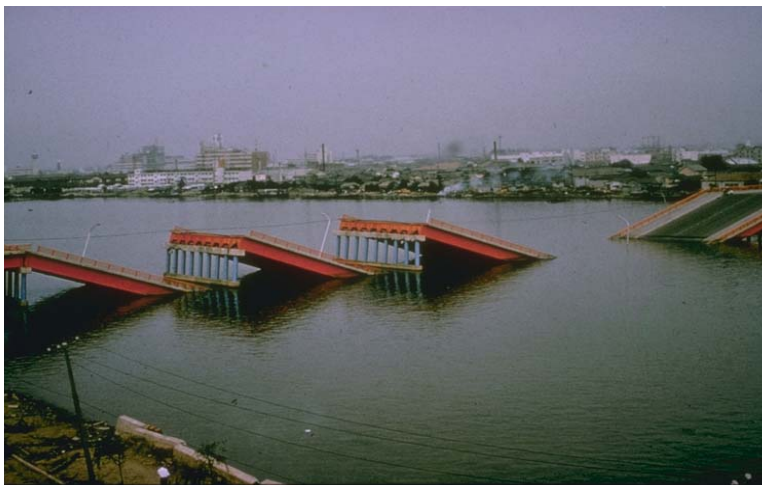
Figure 67 **Total Failure.** Collapse of two piers that resulted in loss of support for the connecting spans. (15)

Figure 67 shows a bridge that had seven spans across the river, each supported by piers consisting of structural steel girders carrying a reinforced concrete deck. Two of the piers collapsed. The corresponding spans of the bridge collapsed and dropped into the river. The successive spans toward the west bank also dropped while one end of each span remained connected at the top of successive piers. The construction was such that one end of the girders was fixed and the other end was free to slide longitudinally off the pier after about 12 inches of movement.

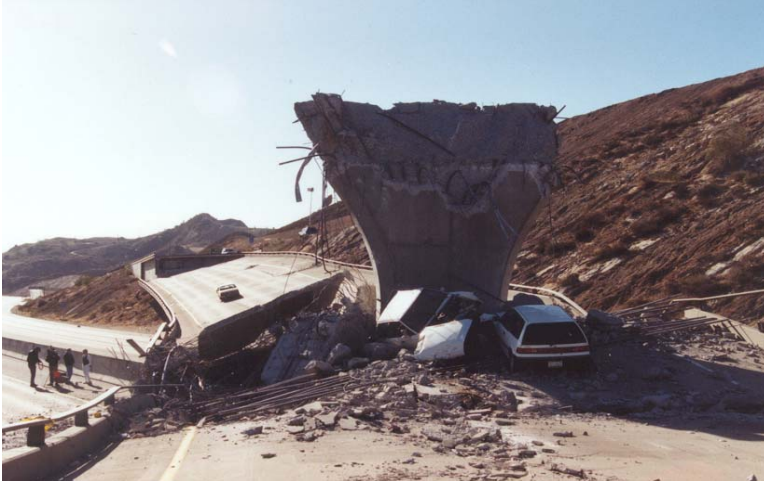
Figure 68 **Total Failure.** Failure of the concrete box girder at the face of the pier cap. (5)

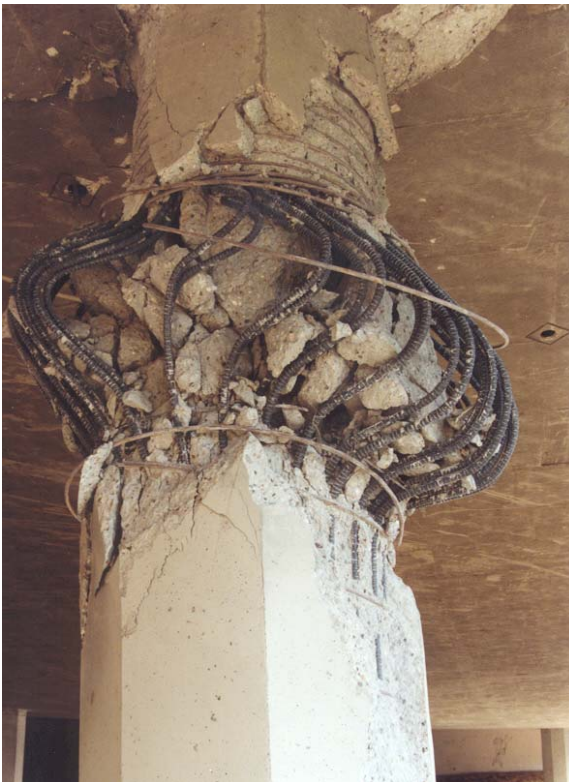
Figure 69 **Total Failure.** Confinement failure in the column. (5)

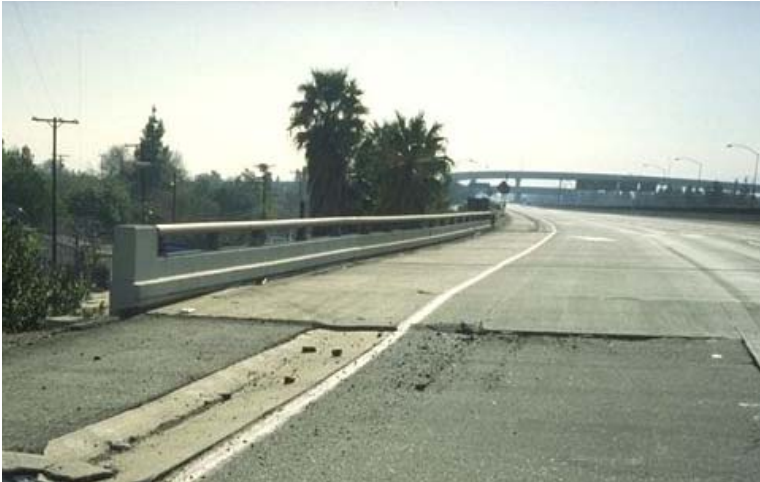
Figure 70 **Minor Damage.** Approach slab settlement at the abutment. (1)

The following example shows a hypothetical bridge that was damaged after a moderately sized earthquake. The bridge is a 3-span, welded plate steel girder bridge that is simply supported at the piers. There are 3 columns per pier and the pier cap has a 12-inch support width. The abutments are “stub” abutments (or seat type) and have slider type bearings. The damage photos are listed in the order of recommended inspection and as shown on the investigation form. The investigation form is filled out showing the appropriate damage levels for this hypothetical bridge.

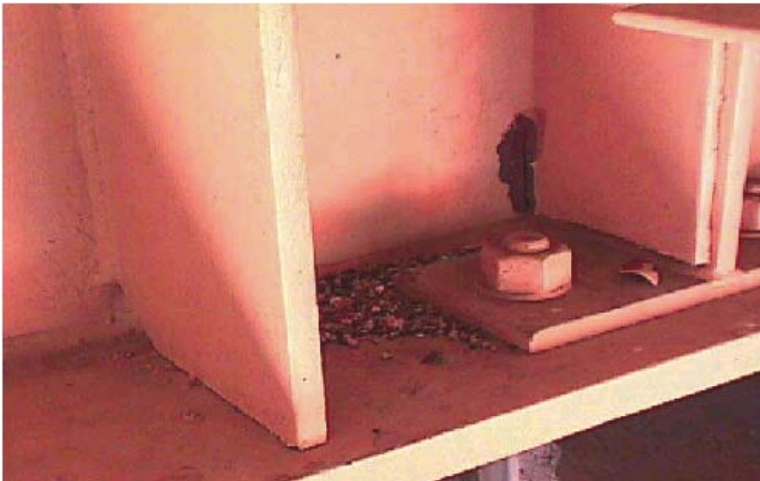
Figure 71 **Minor Damage.** Crack in the girder web/stiffener plate near the abutment. (8)

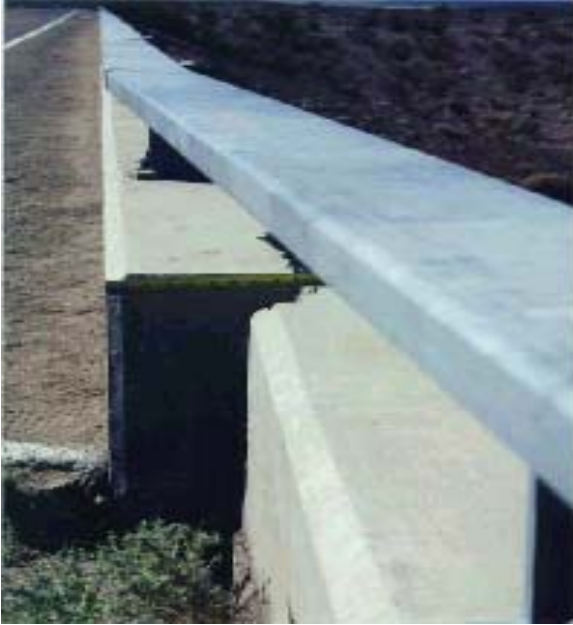
Figure 72 **Minor Damage.** Transverse movement of the abutment wingwall. (8)

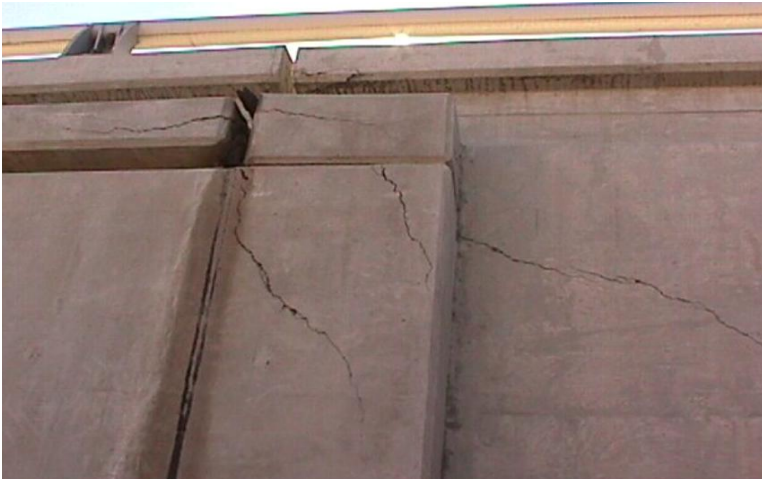
Figure 73 **Minor Damage.** Shear cracking at the abutment wingwall. (10)

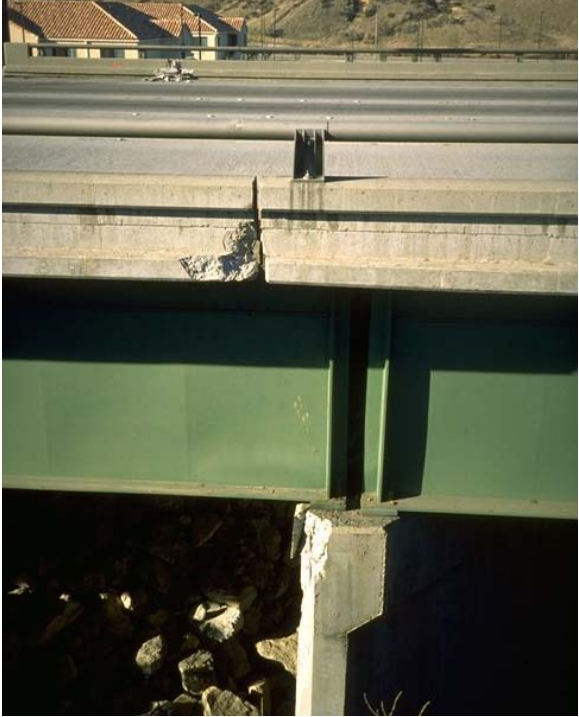
Figure 74 **Moderate Damage.** Anchor bolt spalling and minimal support at the top of the pier.

Minor Damage. Minor cracking of the barrier rail. (1)

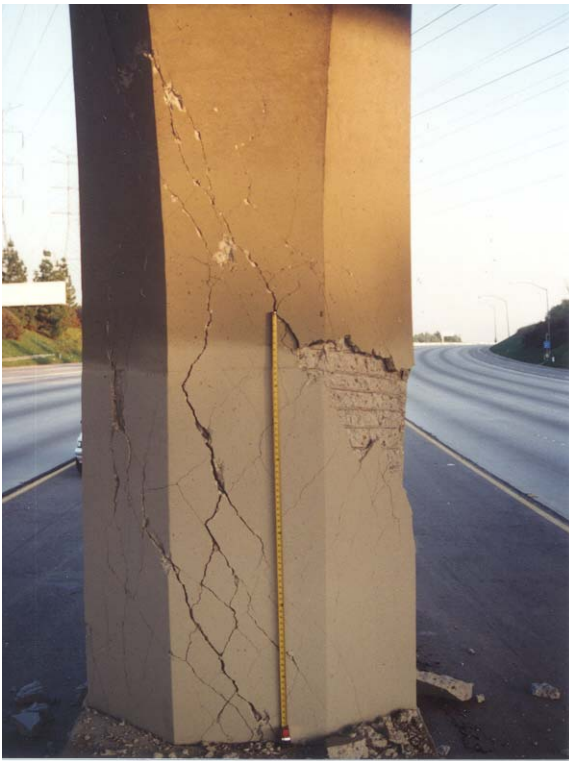
Figure 75 **Minor Damage.** Shear cracking of the concrete cover at the column base. (5)
